UPPER THAMES RIVER ASSESSMENT REPORT

Municipal Drinking Water System Summary - Kilworth-Komoka Water Supply System

Kilworth-Komoka Water Supply System Overview

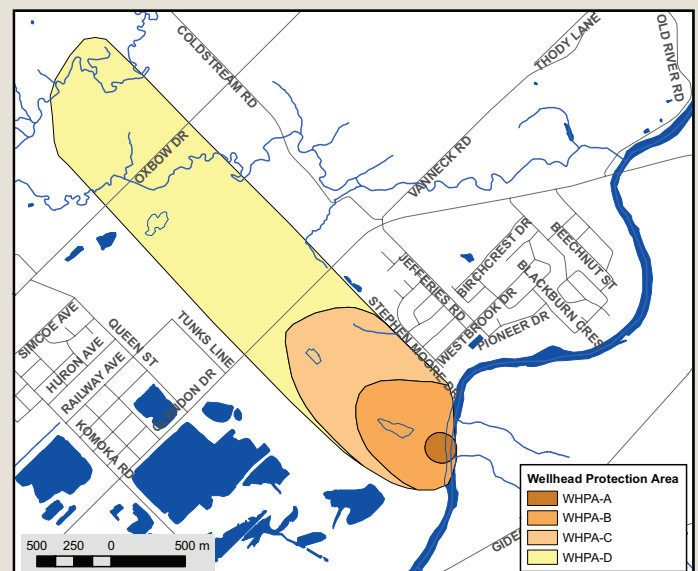
Figure 1. Kilworth-Komoka Wellhead Protection Areas

Computer models and other tools are used to build a picture of the groundwater conditions around a well. In the Upper Thames River Source Protection Area (SPA), numerical groundwater models have been used to delineate WHPAs around the municipal wells (Figure 1). These models calculate the time it takes for water to travel through the aquifer to the well.

Each WHPA is comprised of three areas based on this time of travel, and one area that is a fixed radius around the well.

- WHPA-A – 100 metre radius around the well
- WHPA-B – 2 year time of travel to the well, excluding the WHPA-A
- WHPA-C – 2 to 5 year time of travel to the well
- WHPA-D – 5 to 25 year time of travel to the well

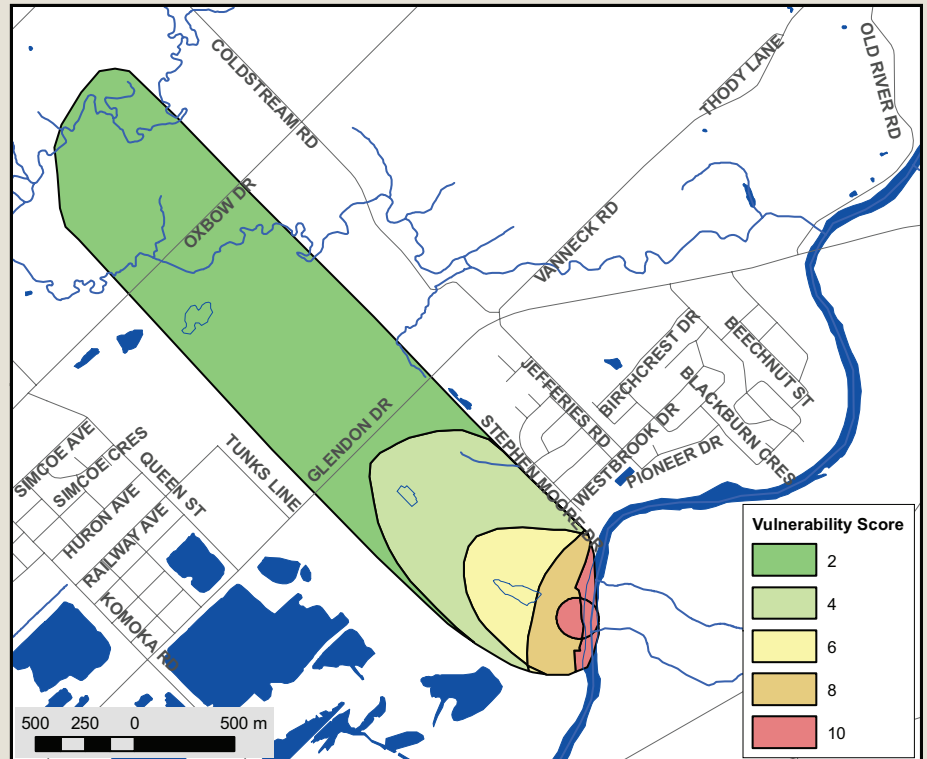
Figure 2. Kilworth-Komoka WHPA Vulnerability Scores

The ISI values were determined to be low within the Kilworth-Komoka capture zones. Based on the WHPA zone and the ISI category, the Kilworth-Komoka wellhead vulnerable areas were assigned vulnerability scores of 2 to 10 (Figure 2) on a 10-point scale, with 10 being the highest vulnerability.

The first step in assessing the vulnerability of the Kilworth-Komoka WHPA was to determine the intrinsic (inherent) vulnerability of the aquifer. The Intrinsic Susceptibility Index (ISI) method was used, which is an index of depth and permeability of the materials that offer protection to the aquifers against possible contamination. The ISI results in a score that can be categorized as high, moderate or low.
